# FACILITY COMPLIANCE INSPECTION REPORT

# Division of Waste Management Solid Waste Section

Bass Mountain Stump Dump LCID Landfill 6225 Wild Horse Canyon Road Snow Camp, NC 27349

Comprehensive Inspection (to ensure that the notified land clearing and inert debris (LCID) landfill is in compliance with 15A North Carolina Administrative Code (NCAC) 13B .0563, .0564, and .0566)

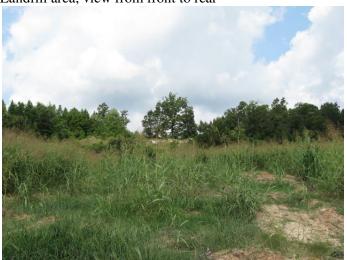
- 3. The LCID landfill is estimated to be ~ 1.5 acres. A raised area contains inert debris that is not included in the LCID landfill footprint.
- 4. The LCID landfill contains soil cover and a vegetative layer.

Landfill area, view from front to rear
